White Paper: Orphaned Outfalls in Rural Virginia Localities

**ORPHANED
OUTFALLS in
RURAL
VIRGINIA
LOCALITIES**

Marsh View Court Outfall Assessment

Isle of Wight County, VA

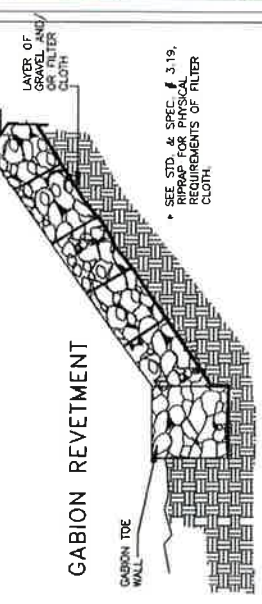
GABION PROTECTION DETAIL (TYP.)

VESCH HANDBOOK 3RD EDITION
PLATE 3.23-1

As the exact extent of the outfall bank erosion is unknown, a structural gabion mat stabilization measure was selected to stabilize the bank and reduce future erosion. Based on aerial imagery and GIS contours, it was estimated that approximately 100 feet of bank would need to be stabilized. In order to construct and install the gabion matting, additional clearing, grubbing, and vegetative bank stabilizing adjacent to the stream will be required.
